**Assessment of the Potential Impact on known Archaeological
Features by Mybster-Dounreay Line Refurbishment Works**

Assessment of the potential impact on known archaeological features by Mybster-Dounreay Line Refurbishment works.

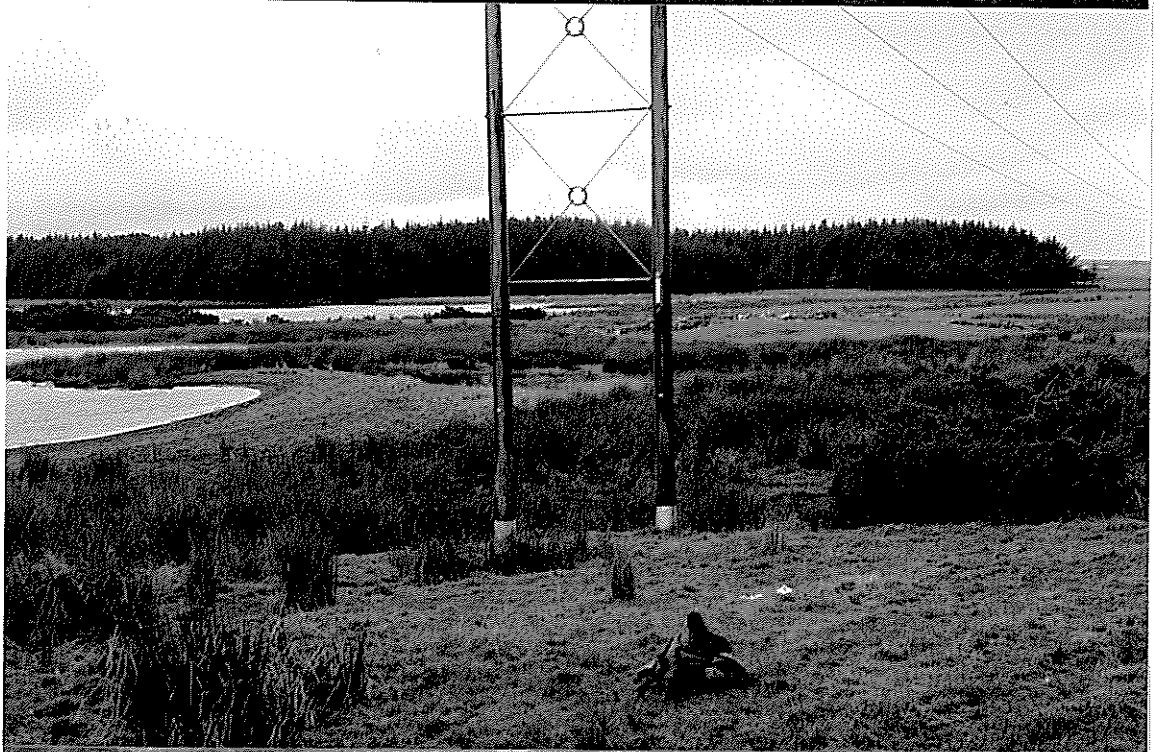
Pole 105 Enclosure at 083 606. The pole stands 10 m. from a NW-SE running fence, on the other side of which is a large rectangular enclosure formed by a low turf and stone dyke. Further low dykes can be traced in the surrounding area, of which at least two run up to the fence, but all trace of their continuation on the west side of the fence is lost. The field in which the pole stands is featureless grassland, and it is concluded that any archaeological record has been effectively destroyed by ploughing and drainage. Access to the line is from the road to the west

Pole 105
View from East
Enclosure in foreground

Action: no specific action considered necessary at this stage.

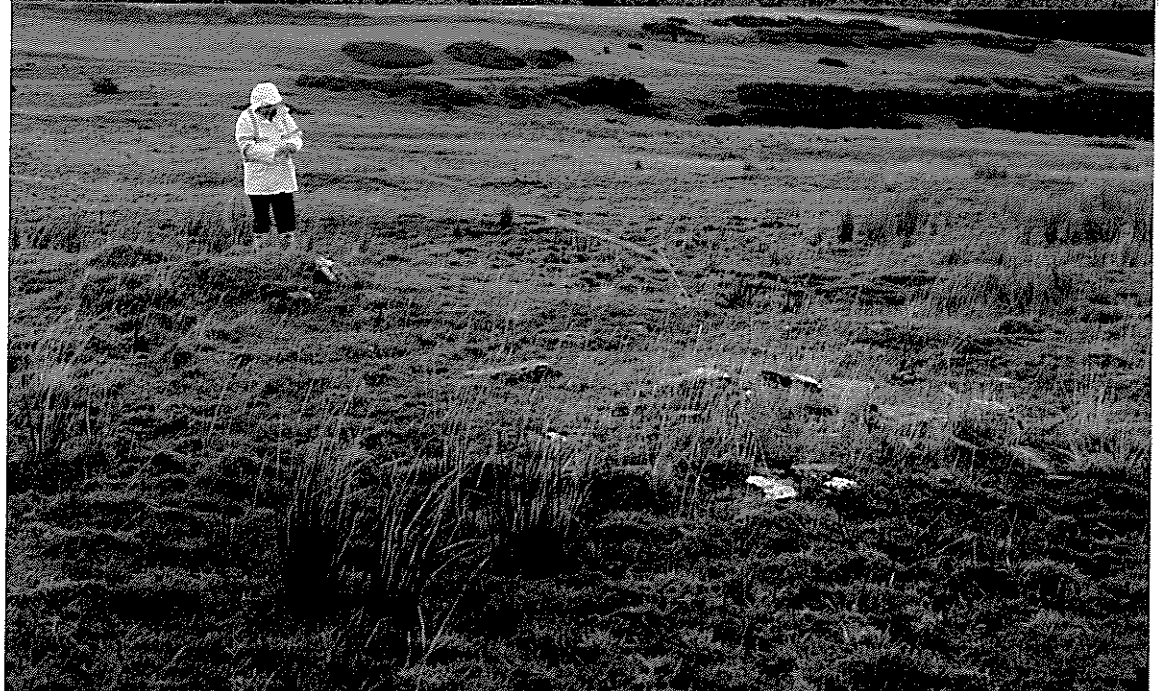
Poles 116 and 119 Chambered cairn at 0706 6190 Farmstead at 0709 6194 Approximately 10m. west of the midpoint between poles 116 and 117 is the edge of the farmstead, consisting of the footings of a house and byre and connected stackyard. (a second farmstead is visible 200m. south along the loch shore) The chambered cairn is on a narrow spit of land extending into the loch, and is partly waterlogged and overgrown with gorse. The water level of Loch Calder, which is a reservoir, appears to have risen considerably and affected both the chambered cairn and a possible line of farmsteads or crofts. Work is to be done on pole 116 and access is from the road to the NE. the terrain is rough and the ground already considerably broken by livestock and farm vehicles, but a reasonable line of access to pole 116 should be possible without encroaching as close as 20m. from the farmstead. The farmstead has already been taped by the contractor.

Pole 116
View from SE

Farmstead is behind R. pole
Chambered cairn is under
gorse on extreme left.

Action: the contractor should be encouraged to use an access route to pole 116 as far to the east as possible, and at least 20m. from the edge of the farmstead.

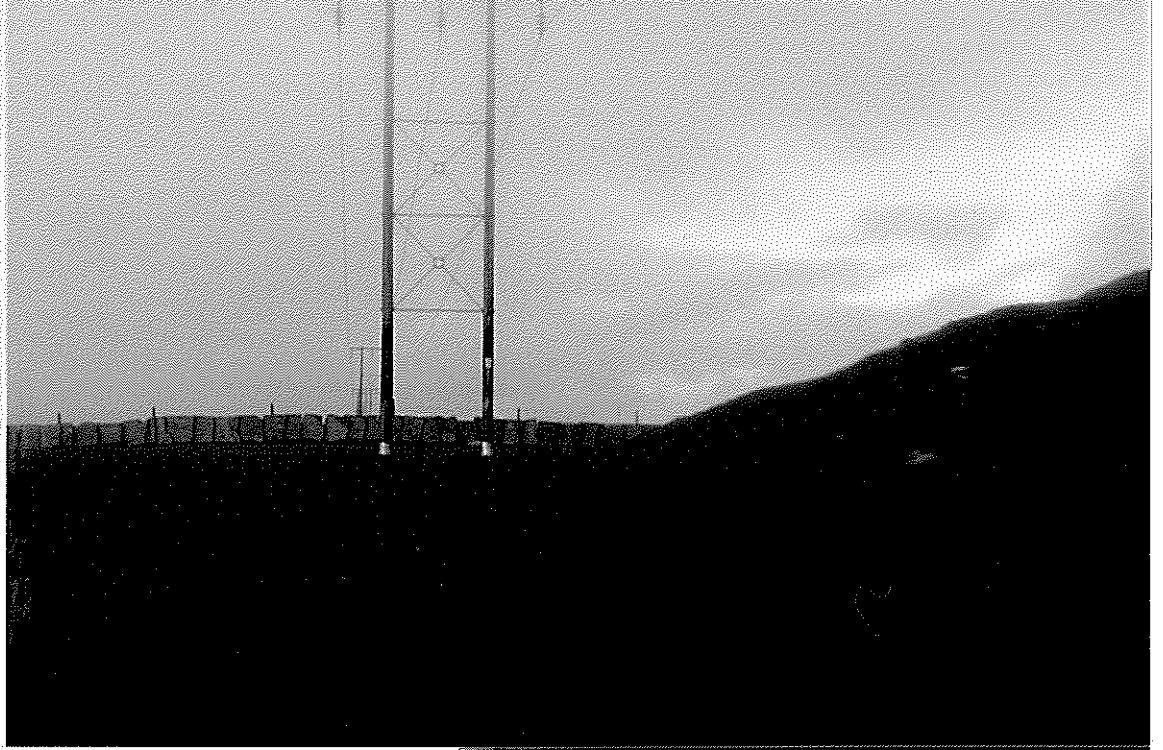
There is an amorphous rubble spread and possible archaeological feature below the line between poles 117 and 118 This has also been taped by the contractor and should not be affected as the access route should pass well to the east

Between poles 117 + 118
Rubble, possible feature

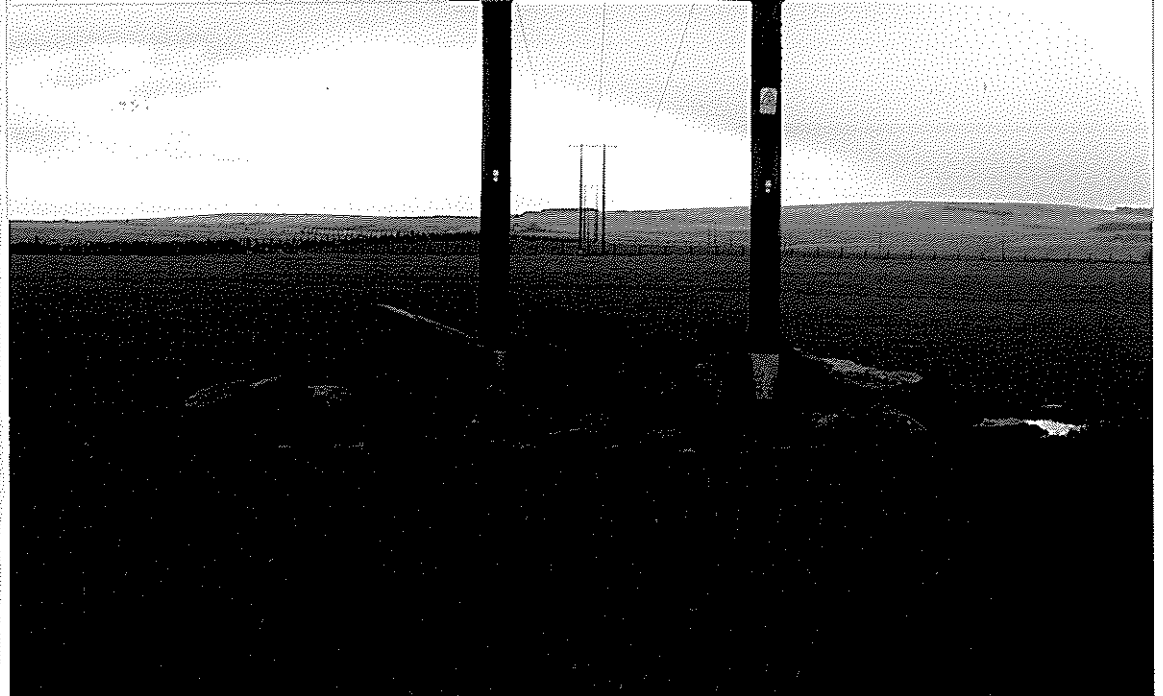
Poles 140 to 146 This section of the line was visited because four archaeological sites are recorded close to the line between poles 140 and 145, including a burnt mound at 0390 6445. The three fields crossed by the line are ploughed and drained grassland, devoid of any visible archaeological feature. The farmer remembers the burnt mound, but admits that it was destroyed by ploughing, and now only shows as an area of discoloration during ploughing. A pile of rubble and earth below pole 140 appears to postdate the erection of the pole.

Poles 141-146
View from SE
showing lack of visible
archaeological features

Action: a desk-based assessment of the four destroyed archaeological features may conclude that an archaeological watching brief is advisable if any future excavation work is carried out. Other maintenance work not requiring excavation should not require any mitigating action.
