VISUAL INSPECTION
FORMER CALEY INN, MUIRTOWN LOCKS,
INVERNESS

Appendix B
Trial Holes

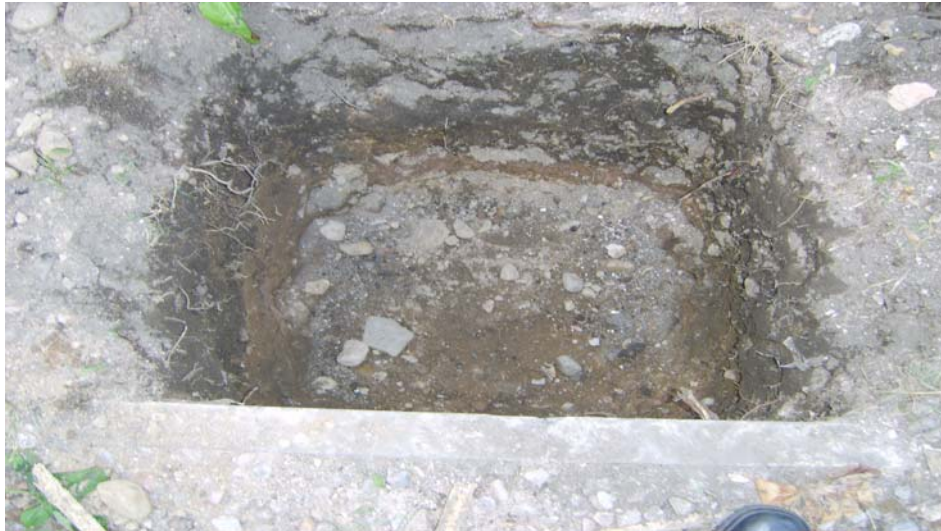
Photograph No 1
Trial Hole 600mm x 600mm x 600mm deep
300mm black top soil underlain with light brown medium coarse sand
interspersed with rounded gravel sized 25mm to 50mm

- The former Caley Inn was built adjacent to the bottom (north) lock gate at Muirtown Locks.
- Given that the tow path in the area is approximately 3 metres above the adjacent retail car park on the other side of the retaining wall it is very likely that the former Caley Inn has been constructed on free draining up-fill material used to construct the Caledonian Canal embankments.
- The material found in the trial hole was consistent with the make up of free draining material.
- While no geotechnical tests were undertaken on site, the ground under the proposed house extensions should have the capacity to safely support a domestically loaded floor slab, conservatory and balcony.

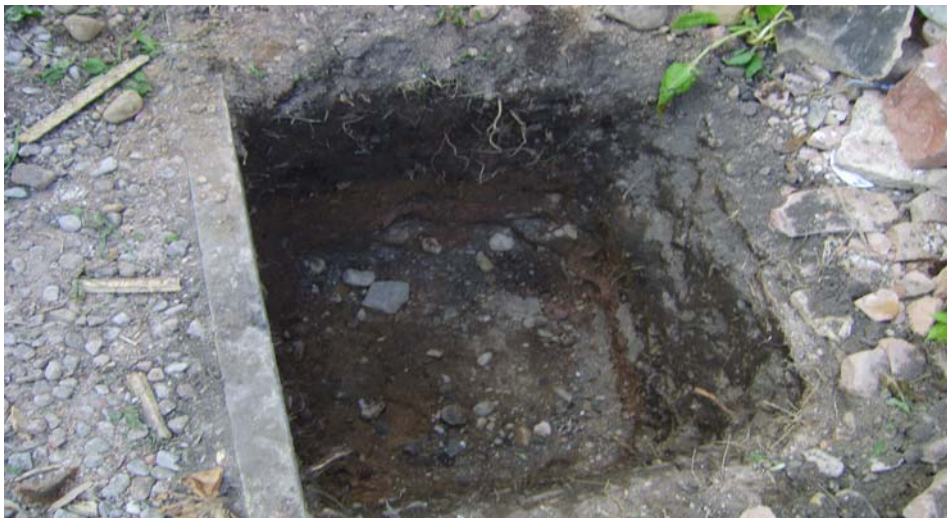
Photograph No 2
Trial Hole 600mm x 600mm x 600mm deep
300mm black top soil underlain with light brown medium coarse sand
interspersed with rounded gravel sized 25mm to 50mm

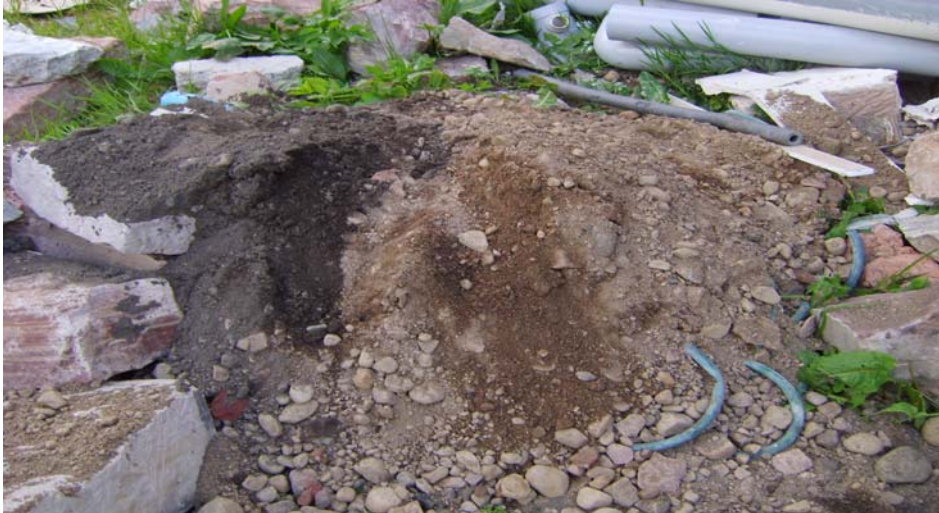
Photograph No 3
Spoil From Trial Hole
Showing black top soil and light brown medium coarse sand interspersed
with rounded gravel sized 25mm to 50mm

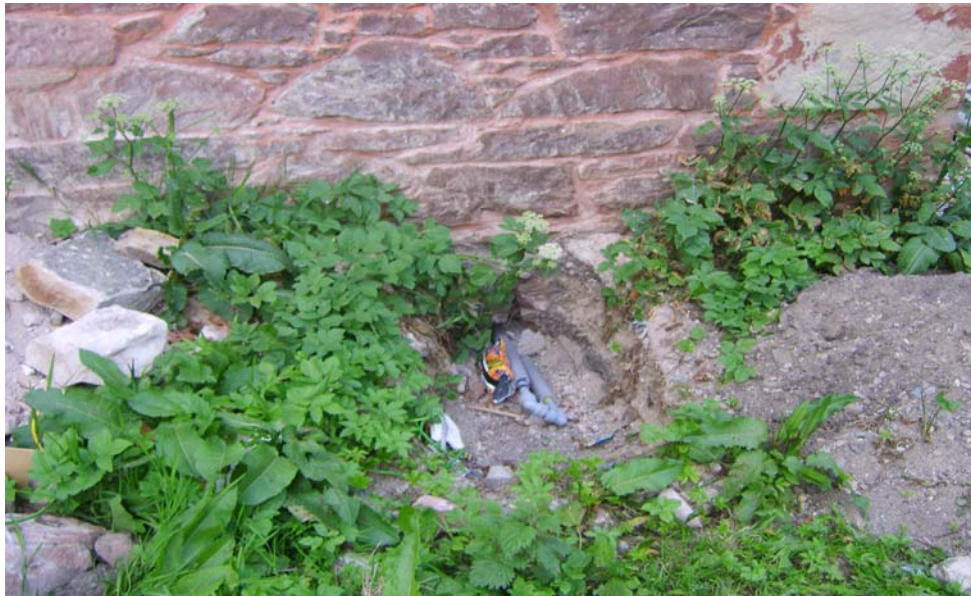
Photograph No 4
Pipes Through / Under Building Foundation
