## HIGHLAND KIRKYARDS: Ross and Cromarty Pilot Project

1. Name of Kirkyard: Kilchrist Graveyard  
from HER (Kilchrist Burial Ground – Highland Council)

2. National Grid Reference: NH 5388 4920

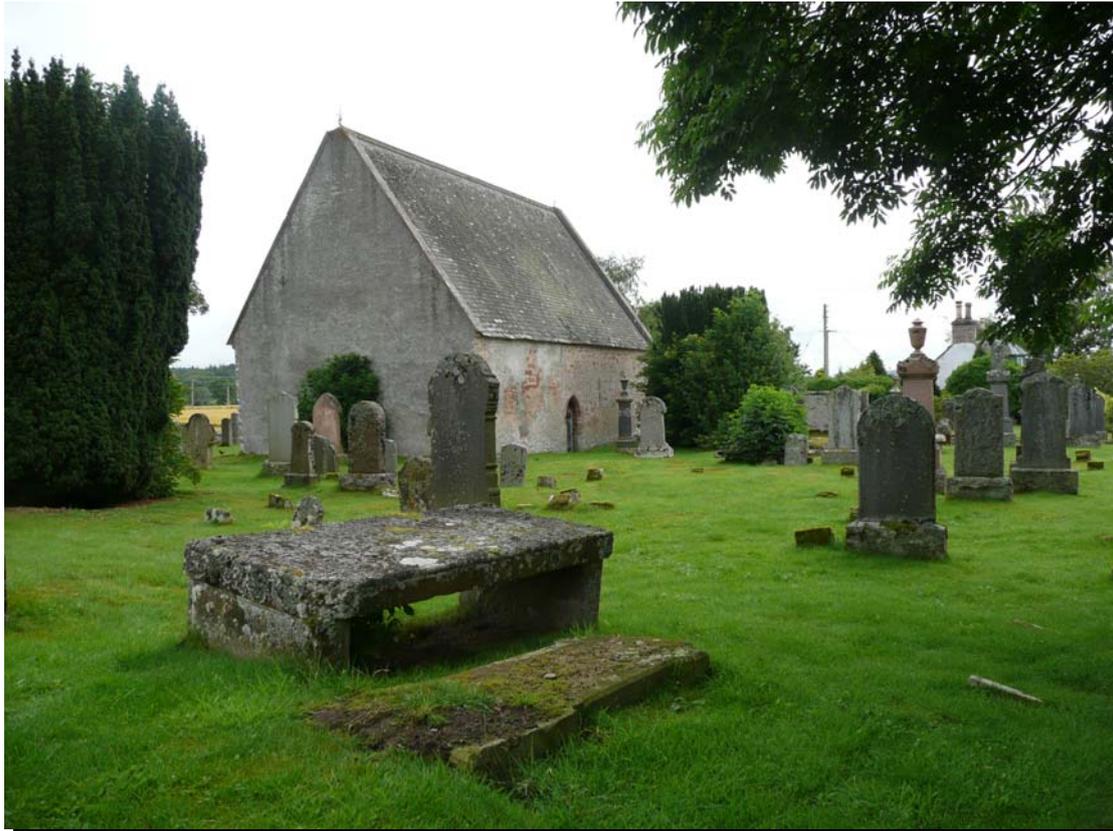
4. Description: A roofed redundant chapel within an old kirkyard. The late medieval church was the scene of a terrible massacre. In 1603, whilst the Mackenzie congregation were inside the chapel, a party of MacDonalds locked them in and set the church ablaze. It is said that the MacDonald piper walked round the church playing to mask the screams of those inside. The church was restored as a shell by W.C. Joass c.1870 and is now used as a mausoleum by the Mackenzie Gillanders family of Highfield. The graves in the burial ground are orientated to the east and the graveyard is reasonably maintained.

5. Setting: Rural. A single-track country road skirts the southern boundary of the kirkyard, leading to farms and farmhouses to the south and east. Open aspect fields to north and west. There are a few trees dotted about the graveyard, including Yews.
