HIGHLANDS KIRKYARDS: Ross and Cromarty Pilot Proforma

1. Name of Kirkyard: Marybank Church, graveyard
(From HER)

2. National Grid Reference: NH 7498 7611

3. Civil Parish: Logie Easter

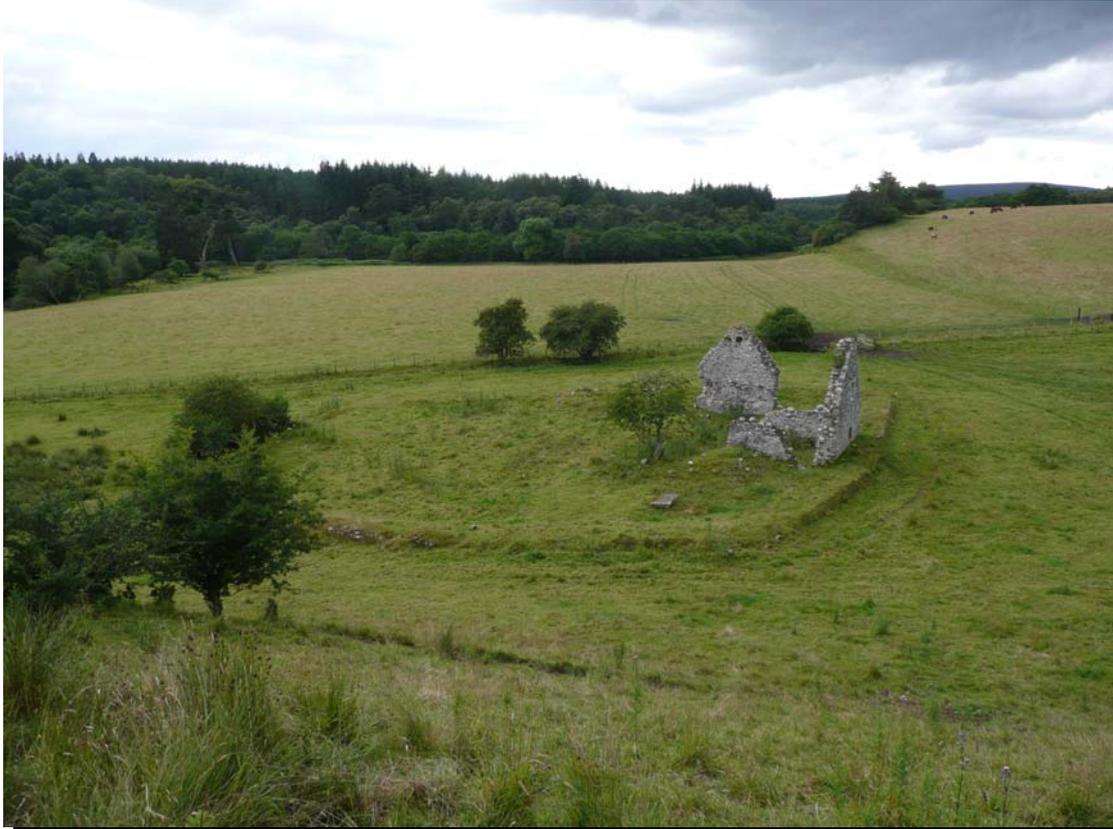
4. Description: Ruined church within graveyard sited in the middle of fields now used for cattle.

The graveyard surrounding the ruined church is rather sparse in gravestones but does still have some visible flat slabs, presumably with more hidden under the grass.
