HIGHLAND REGIONAL COUNCIL

ARCHAEOLOGICAL SITES AND MONUMENTS RECORD

1 SITE CODE		H	N	C	5	1	S	E	0	0	2
2 NGR		N	C	5	9	1	1	1	0	3	5
3 QUAL											
6 SITE NAME		ALTBRECK									
10 GENERIC TYPE		BROCH									
14 PERIOD/DATE		IA					15 DATING METHOD				
							TYP				
18 SHAPE		CIRCULAR									
19 THREAT AND DATE

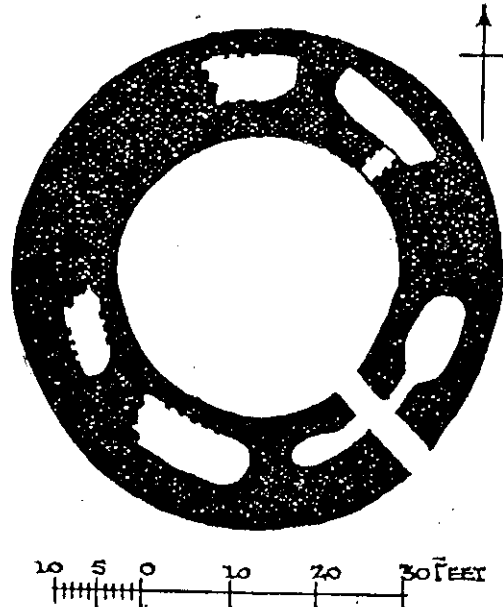
FIG. 56. — Broch, Allt Breac (No. 395).

395. *Broch, Alltbreac.* — At Alltbreac, on the SE. end of a grassy hill, some 150 yards distant from its summit, and about 1 m. E. of Dainnork, are the remains of a broch. It has been sadly dilapidated and used as a quarry for sheep-folds and numerous secondary constructions in its immediate neighbourhood. Of the outer wall little but the lowest course remains, but this shows the masonry to have been very large, as some of the stones composing it are over 3' in length and from 1' 6" to 2' in height. The structure on the interior has been equally demolished, and the outline of the wall is only ascertainable with difficulty. The interior diameter has been about 31' 6", and the thickness of the wall 13'. The entrance has been from the SE., and seems to have been about 3' wide through a passage 13' in length. The door checks, if any existed, have gone, and the sides are much ruined. There have been chambers on both sides entering from the passage; that on the right about 6' 4" in from the exterior,

that on the left perhaps a little further in. The chamber on the right is entered by a passage through the wall 1' 8" wide and about 4' long. The chamber itself has been about 10' long, but, as the roof and outer wall are gone, its other dimensions are unobtainable. The passage into the chamber on the left seems to have been about 2' 6" in length and 2' broad. The chamber has been about 7' long and only about 2' 8" broad, but its ruined state makes the measurements rather unreliable as to its original form. Some 4' S. of the end of it is the back wall of another chamber, still 6' high and 4' 10" wide. Its length is unascertainable with certainty, as the W. end is blocked up with ruins, but it appears to have been about 7', and a continuation for other 8' westward of its S. wall most probably indicates the position of the stair. At 5' 6" further W. is the S. end of another small chamber, which has been about 4' wide, and is filled with stones. Following the curve of the wall in the opposite direction from the E. side of the entrance the back of a chamber lying to the N. is met with at about 44' 6". It has a width of about 5', but, as the wall on the outside or NE. is perpendicular and built against the rounded wall at the back, it has probably been originally wider. 3' 6" to the E. of it is the end wall of another chamber running SE. for 13'. The outer wall here also presents the same features as in the previous case. The span of the original roof has probably been too great, and an additional wall has been necessary for its support. The present greatest width of this chamber is about 3' 6". The original outworks are not distinguishable from the remains of folds, etc., around the broch (fig. 56).
