HIGHLAND REGIONAL COUNCIL

ARCHAEOLOGICAL SITES AND MONUMENTS RECORD

1 SITE CODE	H	N	C	8	6	N	E	0	0	2
2 NGR	N	C	8	5	6	6	6	2	6	CE
3 QUAL

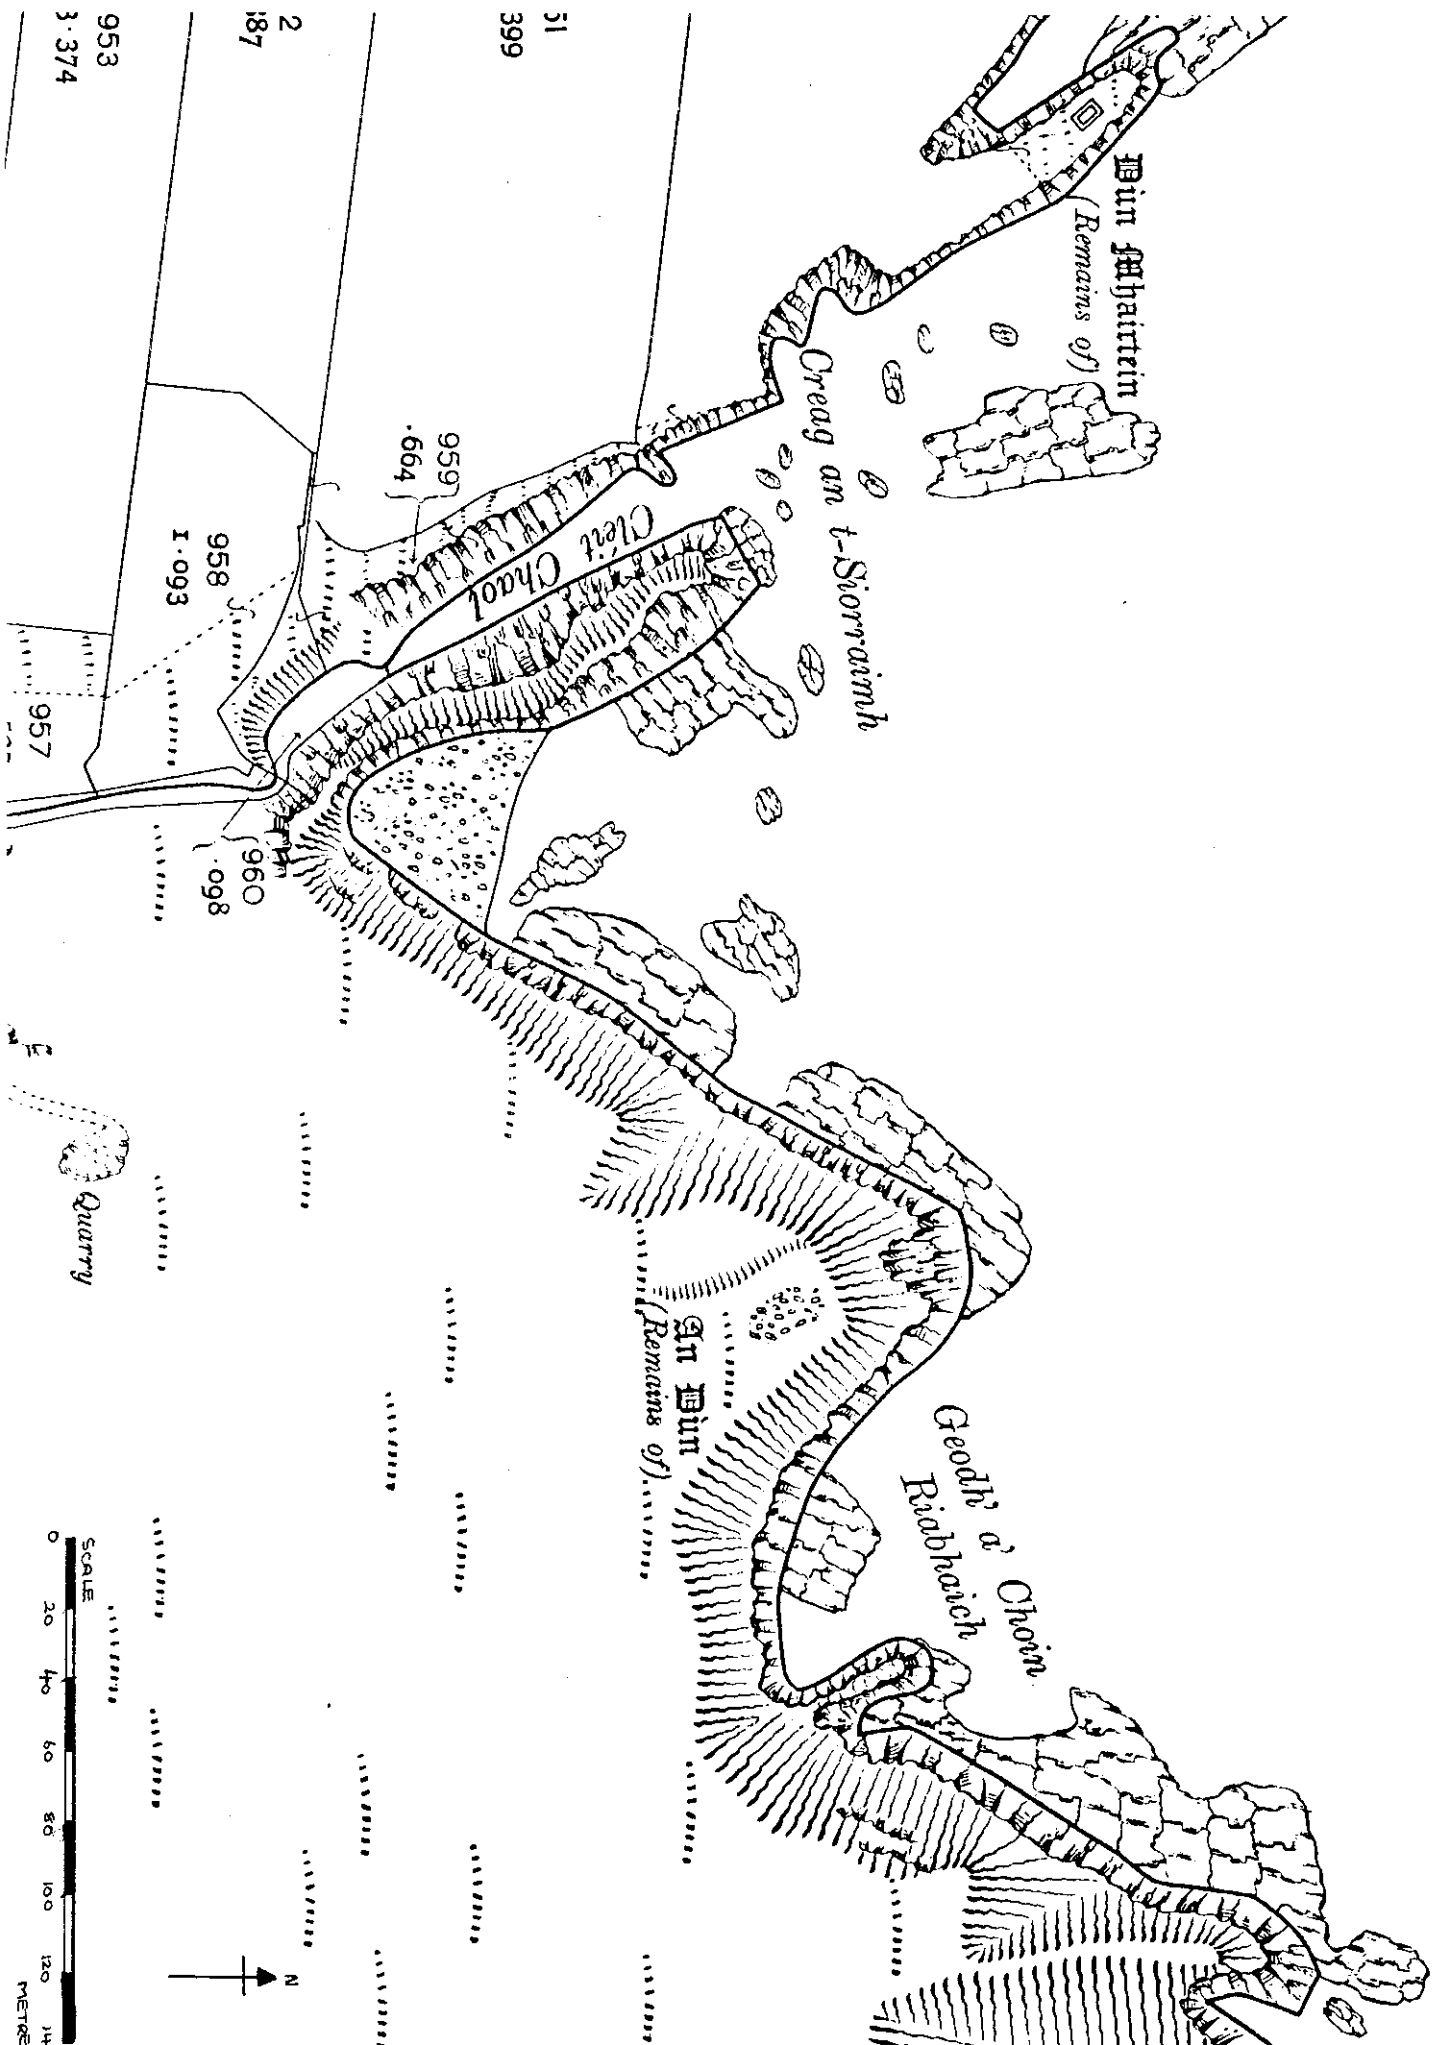
Mon 233

Mon. No. 233 (Fig. 29) 'An Dun' (not included by Lamb) may represent a similar site type with a massive defensive rampart structure - sadly, however, entrance details are no longer available. Curle (RCAHMS 1911a) remarks that "A parapet some 6' in thickness has been built round the edge of the cliff; and about 15' back from it, at the centre of the curve, are the foundations of a structure measuring interiorly about 20' x 8'." The O.S. sketch plan of 1972 (O.S. Card NC 86 NE 2) notes the apparent rectangularity of the structure but also notes an inner face to the 'parapet' of Curle, noting that the outer face has disappeared. The enclosure of the remnant 'parapet' if reconstructed as circular would form a structure some 15m in internal diameter with a wall thickness of 2m described by Curle. Such a wall thickness would seem somewhat diminutive for this structure to have been a ruined broch but the possibility exists. The later(?) rectangular(?) structure, if such it be, set within the wrecked 'parapet' may possibly relate to the kind of tower-keep to which reference has already been made. The site is very badly ruined (and there is also the distinct possibility of recent disturbance as the marked depression in the NE corner of the subrectangular structure is not noted either by the O.S. (1972) or by Curle (1909)) so such suggestions must remain most tentative but the possibilities of a complex sequence of events may be present here.
