HIGHLAND REGIONAL COUNCIL

ARCHAEOLOGICAL SITES AND MONUMENTS RECORD

(NH 582 735) Balna Crotchen: A possibly short horned
cairn with a polygonal chamber.

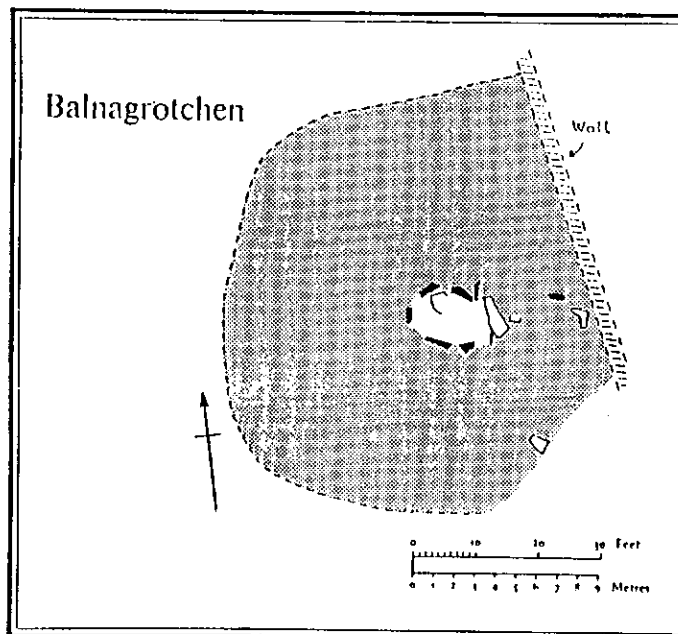
FIG. 73

5 BALNAGROTCHEN
(O.-C., polygonal, ? short
horned)
In the parish of
ALNESS
Location in the valley of the
RIVER ALNESS
2½ m. below
LOCH MORIE
Map reference
NH/581735
Sheet LII SE; NH 57 SE
Reference D. and F. (1956) 24
Plan by E.V.W.F. and A.S.H.
(fig. 73)
Visited 5.7.58

Description. The site lies at the edge of a field on the terrace above the river, at just under 700ft. OD. It is less than ¼ mile S of the other two chambered cairns at Boath which can be seen from the site. The cairn material has been largely removed so that a depth of only 2 or 3 ft. remains. The cairn now appears to be square in plan with a diameter of about 60ft., but it is difficult to know how far this shape is due to the ploughing of the field. There are various large boulders lying about the site but they do not seem to form part of the structure. A field wall crosses the E edge of the cairn.

In the centre there are a number of split slabs which have formed the main stones of a chamber entered from the E. Only one stone of the passage or outer part of the chamber can be seen, evidently part of the N wall; another leaning slab farther to the W might be part of the opposite wall. The top of this stone is level with the ground but a hole beside it shows it is at least 2ft. 9in. high. To the W of it are two transverse slabs flush with the present ground level. Both stones appear to be *in situ* but they are not placed opposite each other as is normal. Within these stones five more define a large oval chamber. The back-slab is only 8in. high, the others ranging from 1ft. 9in. to 3ft. 4in. high. Inside the chamber are lying a number of large flat slabs, evidently part of the roofing. (1)
