TAIN AIRFIELD**Building Record****Area K****No. 4****NGR NH****Description**

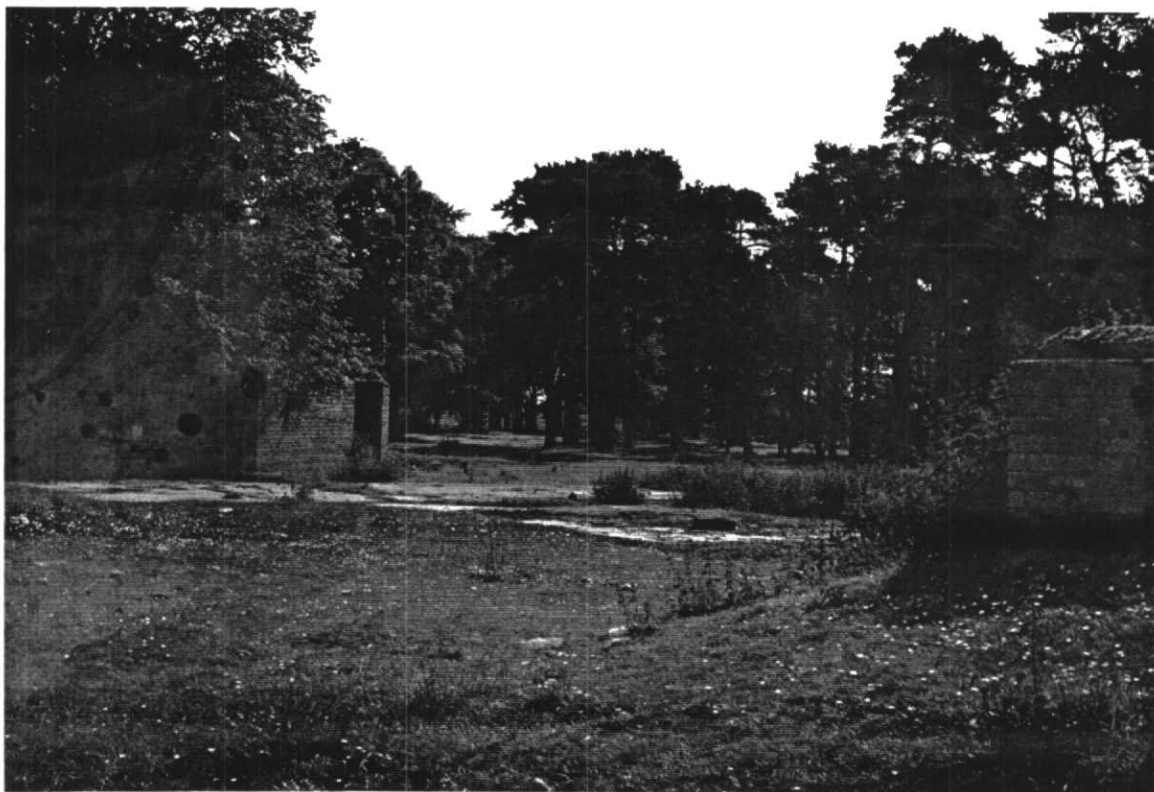
To the W of the entrance to Loans of Bogbain Farm are the remains of 3 structures thought to belong to the war time use of Tain Airfield. The remains include a red brick store with glass set in concrete on the wall head. An iron framed gate with wire mesh still survives here. To the W is a grey brick foundation also topped with glass embedded mortar at it wall head. It is partially banked with soil. Between these 2 standing structures is a T-shaped foundation. Other foundations may lie in the woodland to the W and E, though this area was not surveyed further

The standing structures are in good condition.

**Photograph No.****33B****Date 02/07/99****Looking****NE at all 3 structures**
