Watching Brief

Londubh Burial Ground Poolewe

Report No.	HAS060906
Site Code	HAS/LBG06
OS Grid Reference	NG 8603 8096
Planning Ref	N/A
Client	Highland Council
Report date	16 September 2006
Authors	M Peteranna and J Wood

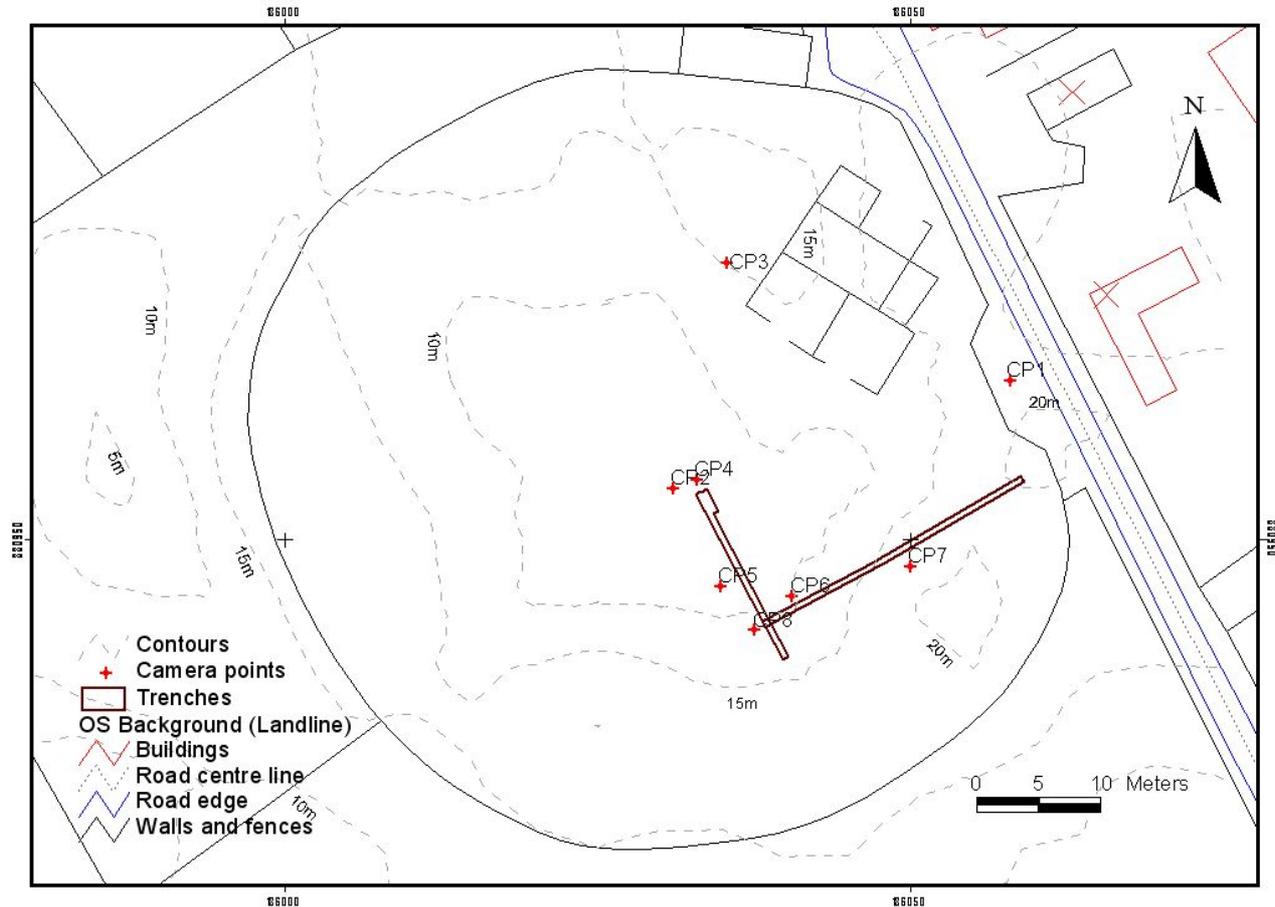
Figure 2 Site plan showing trench and camera locations

During the first day, the north end of Trench 1 (1.1m by 1.9m) was dug and the former drainage connection identified by its gravel covering. The area around the connection was wider to facilitate connection to the new pipes. During day two, the remainder of Trench 1 (13.1m by 0.5m) was dug from north to south.

On the third day, Trench 2 was dug from west to east from the point of intersection with Trench 1. It measured 22.75m by 0.5m. Turf was also cleared from an area measuring 3.27m by 6.45m directly inside the site entrance.

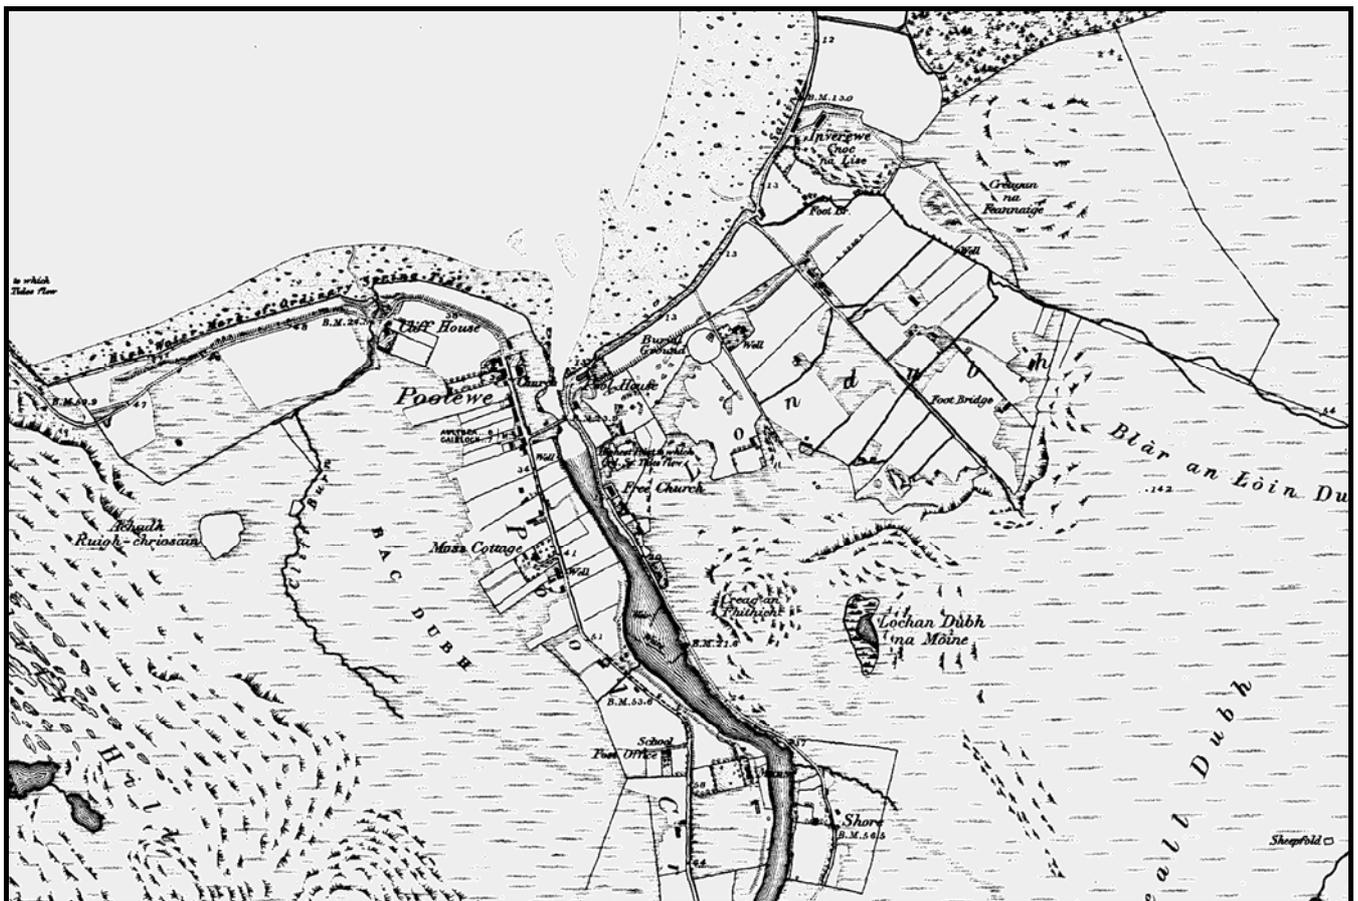
Figure 3 First Edition Ordnance Survey 6 inch map, 1881
(Not to scale)

The fields to the S and W of the graveyard contain grass-covered stony mounds and field banks, probably of various dates (SMR NG88SE0057-8), which pre-date the field patterns shown on the 1st edition Ordnance Survey map. These have not been investigated archaeologically but some could be early medieval or even Bronze Age in date (approx. 4,400 to 2,700 years ago).

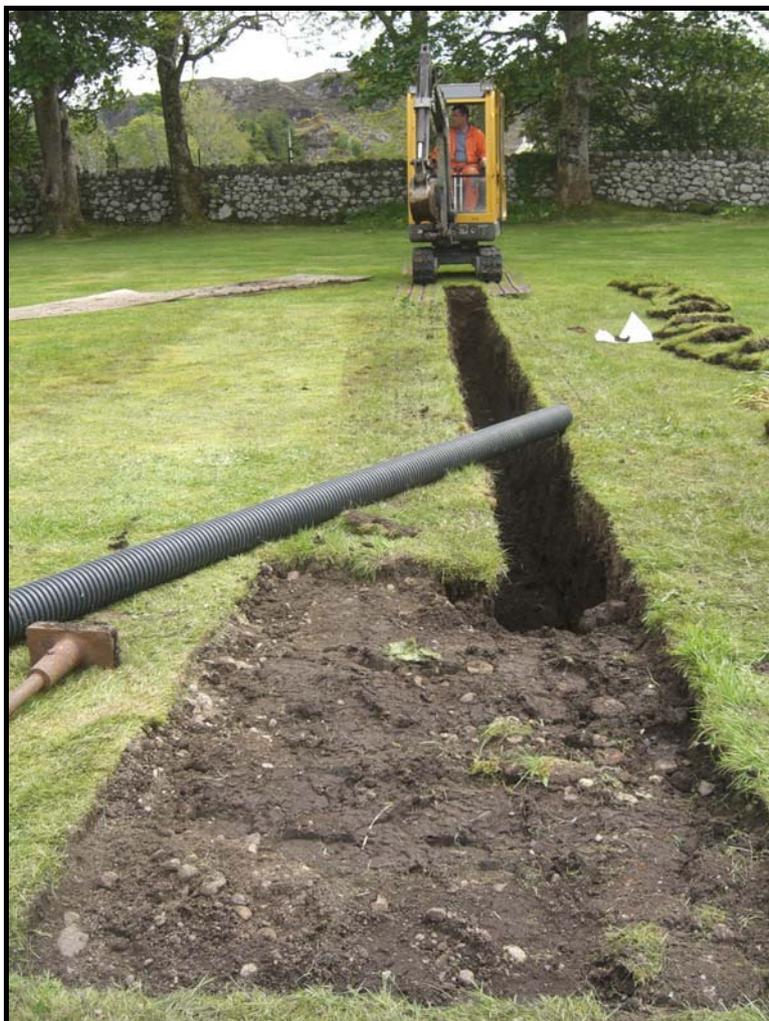
Figure 5 Trench 1 View south

No archaeological features or finds were recorded. Within the last third of Trench 1, numerous fragments of the original drainpipe were found scattered throughout the topsoil.

The trenches did not contain archaeologically significant features, and no further archaeological work is recommended in connection with the drainage pipe installation.

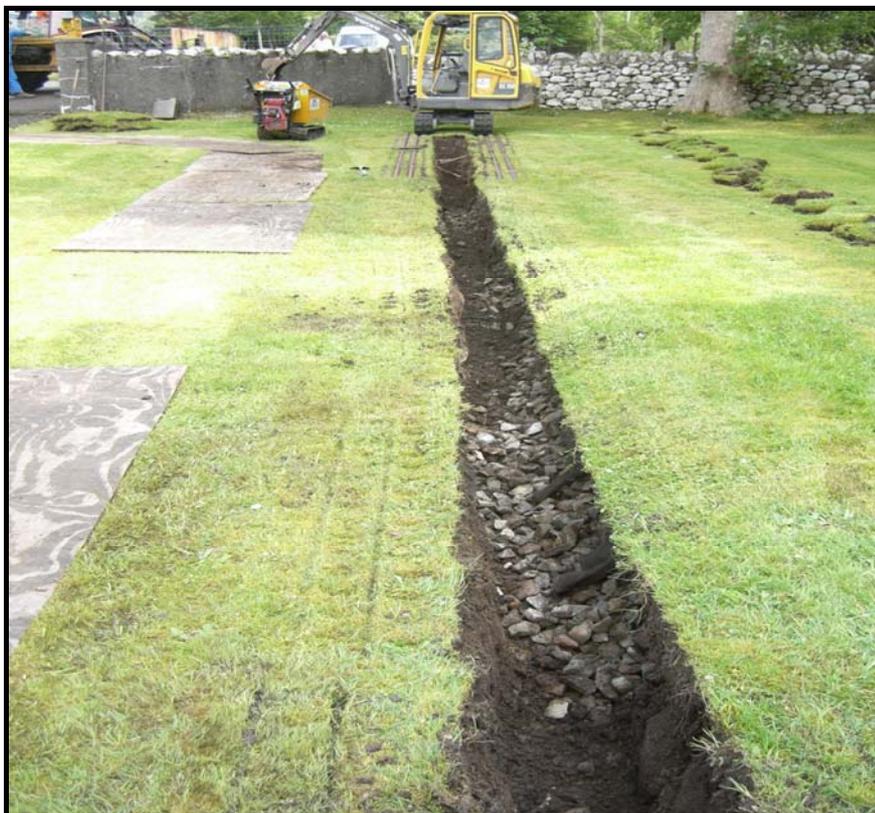
Figure 6 Trench 2 View east

No archaeological features or finds were recorded. There were additional fragments of the original drainpipe scattered throughout the topsoil at the start of Trench 2. The last third of Trench 2 ran along the same line as previous recent drainage trenches on site—evidenced by the cloth underlain by gravel fill (see fig 6).
