**Assessment of the Potential Impact on known Archaeological
Features by Mybster-Dounreay Line Refurbishment Works**

Assessment of the potential impact on known archaeological features by Mybster-Dounreay Line Refurbishment works.

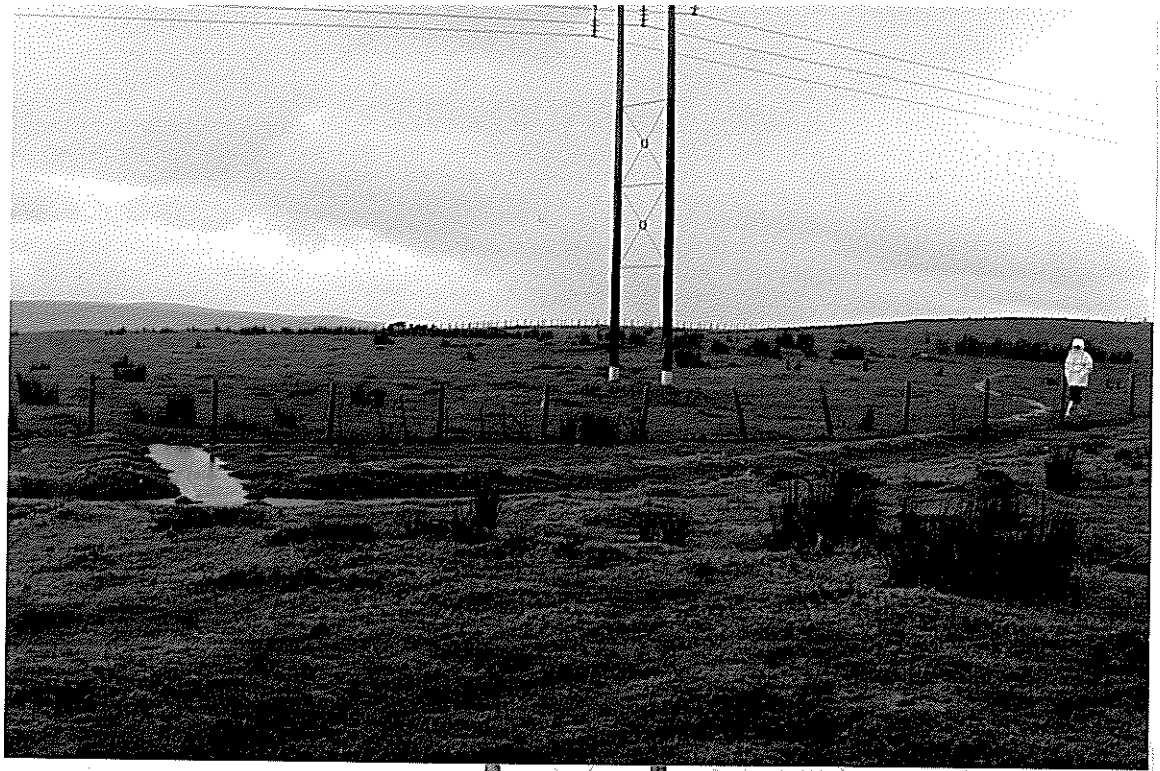
Pole 116
View from SE

Farmstead is behind R. pole
Chambered cairn is under
gorse on extreme left.
