## HIGHLAND KIRKYARDS: Ross and Cromarty Pilot Project

1. Name of Kirkyard: Brahan Castle, Angel Statue  
(From HER)

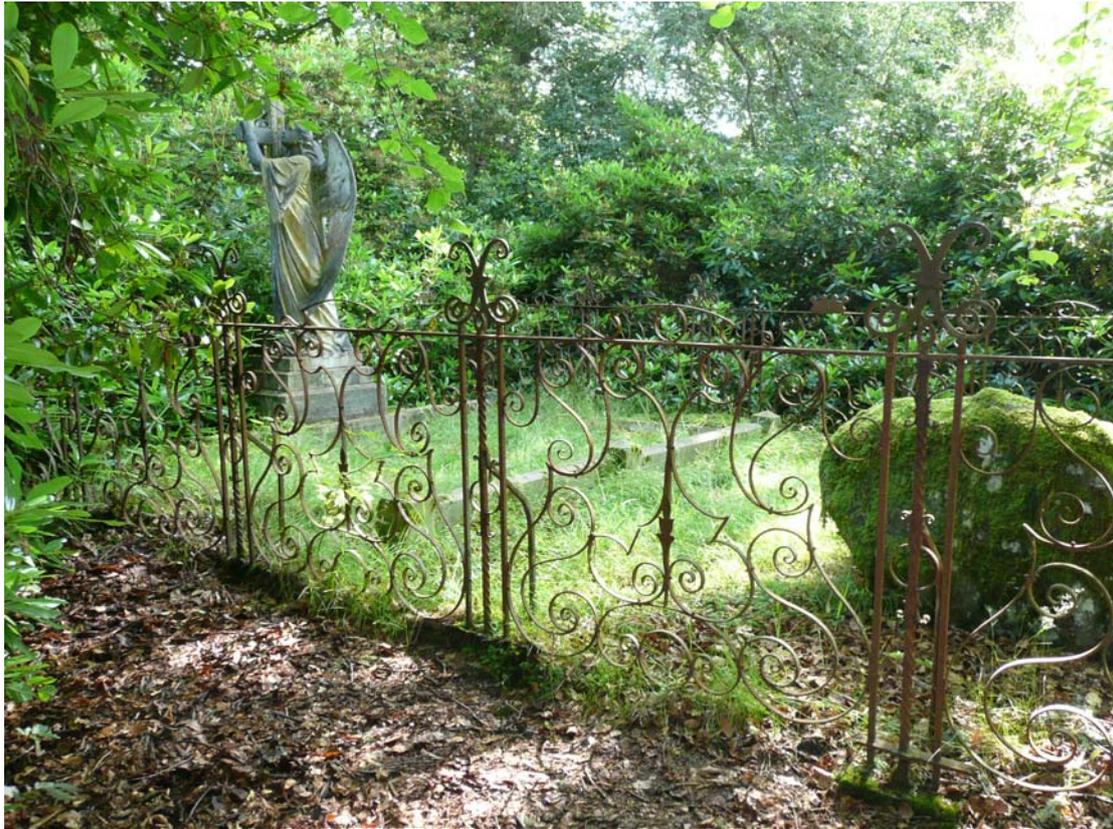
Burial Enclosures: The Seaforth burial enclosure is surrounded by ornate, rusted iron railings with delicate scroll detailing. The entrance gate is at the far side of the burial enclosure, indicating that the original approach may have been from this side. Made from rusted iron, the gate is topped by a symbol of a crown.

Vegetation surrounds the burial enclosure, but does not overwhelm it, indeed it adds to the tranquil atmosphere. Inside is a large, impressive statue of an angel marking the burial place of the last Lord Seaforth. The statue is surrounded by a low stone wall which is missing sections and has loose stones. There is also an unidentified large rock within the burial enclosure. Outside the enclosure some small patches of large pebbles in the ground which look almost like cobbles.

9. Risk: The site is in well tended woodland and although vegetation surrounds the site, it is not causing any damage. The Angel statue is need of some maintenance around the base
