## HIGHLAND KIRKYARDS: Ross and Cromarty Pilot Proforma

1. Name of Kirkyard: Gruinard House  
(From HER) (Gruinard Burial Ground – Highland Council)

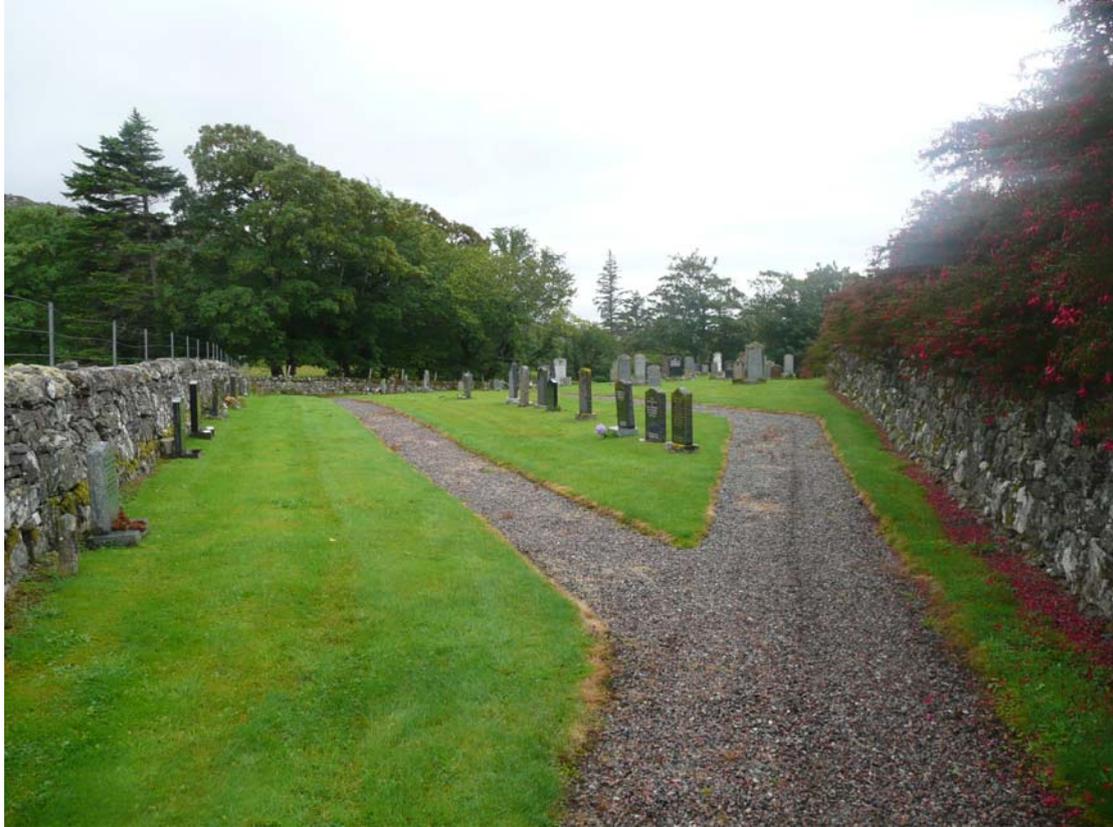
4. Description: Graveyard in use with no church in use or redundant. The burial ground is roughly triangular in shape. The oldest burials are in the south-west corner of the site, where the ground is decidedly raised, although it is hard to tell why. The eastern and northern sides of the burial ground are flatter and contain the more recent burials. There are flat unreadable slabs on the ground and uprights from the late 19<sup>th</sup> and 20<sup>th</sup> centuries.
