HIGHLAND REGIONAL COUNCIL

ARCHAEOLOGICAL SITES AND MONUMENTS RECORD

1 SITE CODE
H N M 9 5 N E 0 0 1

6 SITE NAME
D U R O R C H U R C H

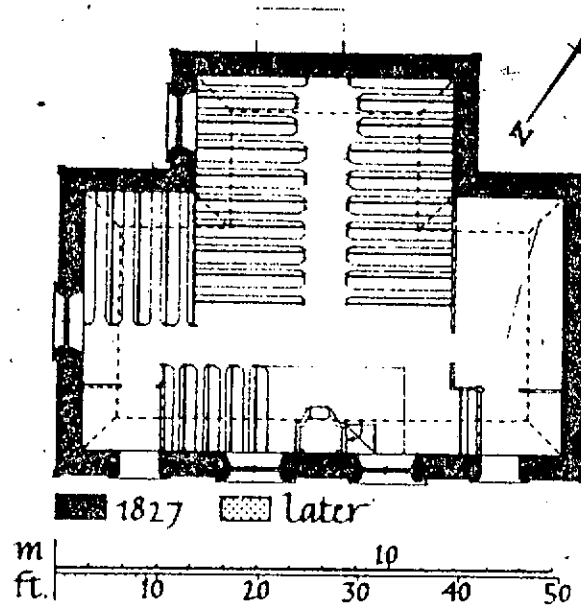
Fig. 118. Parish Church, Duror (No. 244); plan

The building is of T-plan form (Fig. 118) and conforms closely to Telford's published design for a Highland church.³ The main block measures 16.1 m from NE to SW by 9.4 m transversely over all, while the wing measures 3.7 m in depth and 9.3 m in width over all; the walls have a thickness of 0.76 m. The masonry is of coursed rubble with offset quoins and dressings of pink sandstone. The roof is gable-ended, the SW gable being surmounted by a bird-cage belfry capped with a pyramidal finial. The principal, or NW, elevation (Fig. 119) incorporates a pair of large four-centred arch-headed windows flanked by corresponding doorways. The windows have cast-iron mullions and transoms containing small lozenge-shaped panes set within cast-iron frames. The other windows of the church are similar in form, but now lack their original mullions and transoms. The interior (Pl. 24B) has been remodelled and now presents no features of interest, but the pulpit still occupies its original position against the centre of the NW wall; there may formerly have been a gallery.
